Deciphering Land Subsidence in Kediri, East Java through Integrated Geophysical Investigation

Abstract

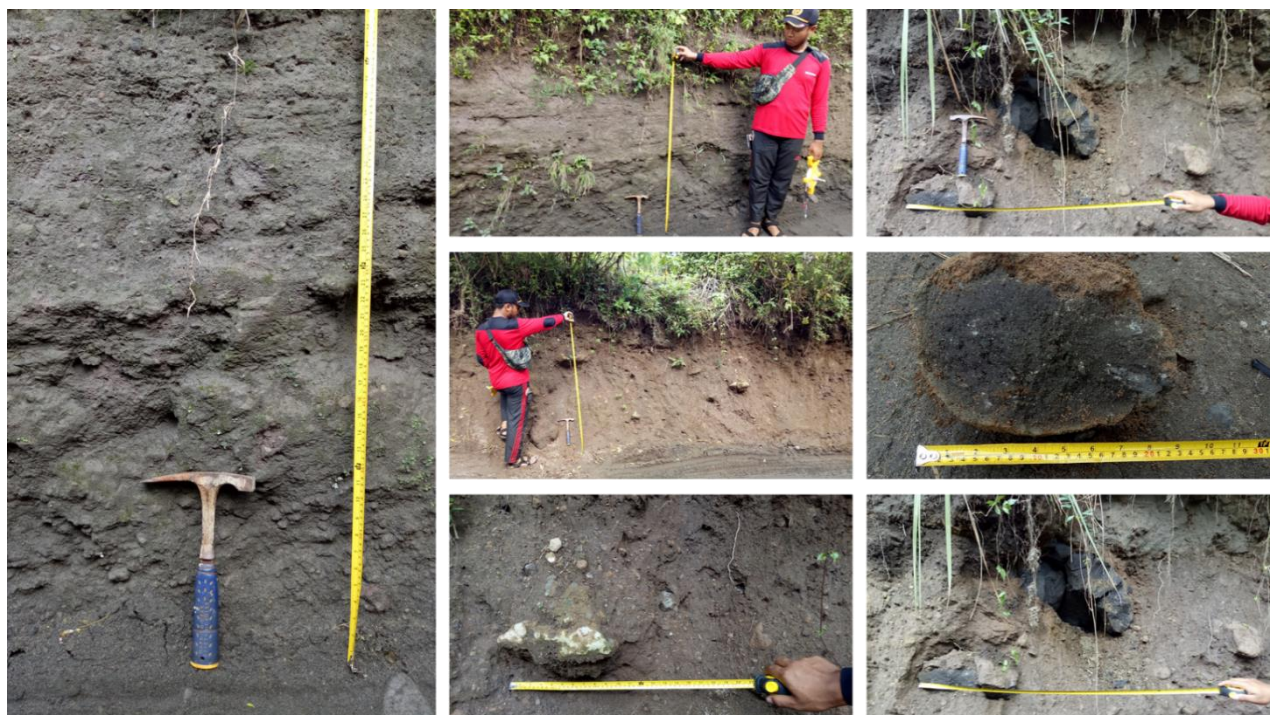
Figure 9 Volcanic sediment outcrop of Kelud Muda (Qvk) is located in the southeast slope of Mount Kelud. This agglomerate-composed volcanic sand layer was found in resident well at 5-13 m depth.

The recorded video data from underwater cameras in a non-collapsed well shows from the top to the bottom of the well. A brick wall wells up to a depth of about 8 meters come in contact with volcanic rocks in the form of compact pyroclastic breccia (with agglomerate fragments as in depths 8 to 14 m) (Figure 9).

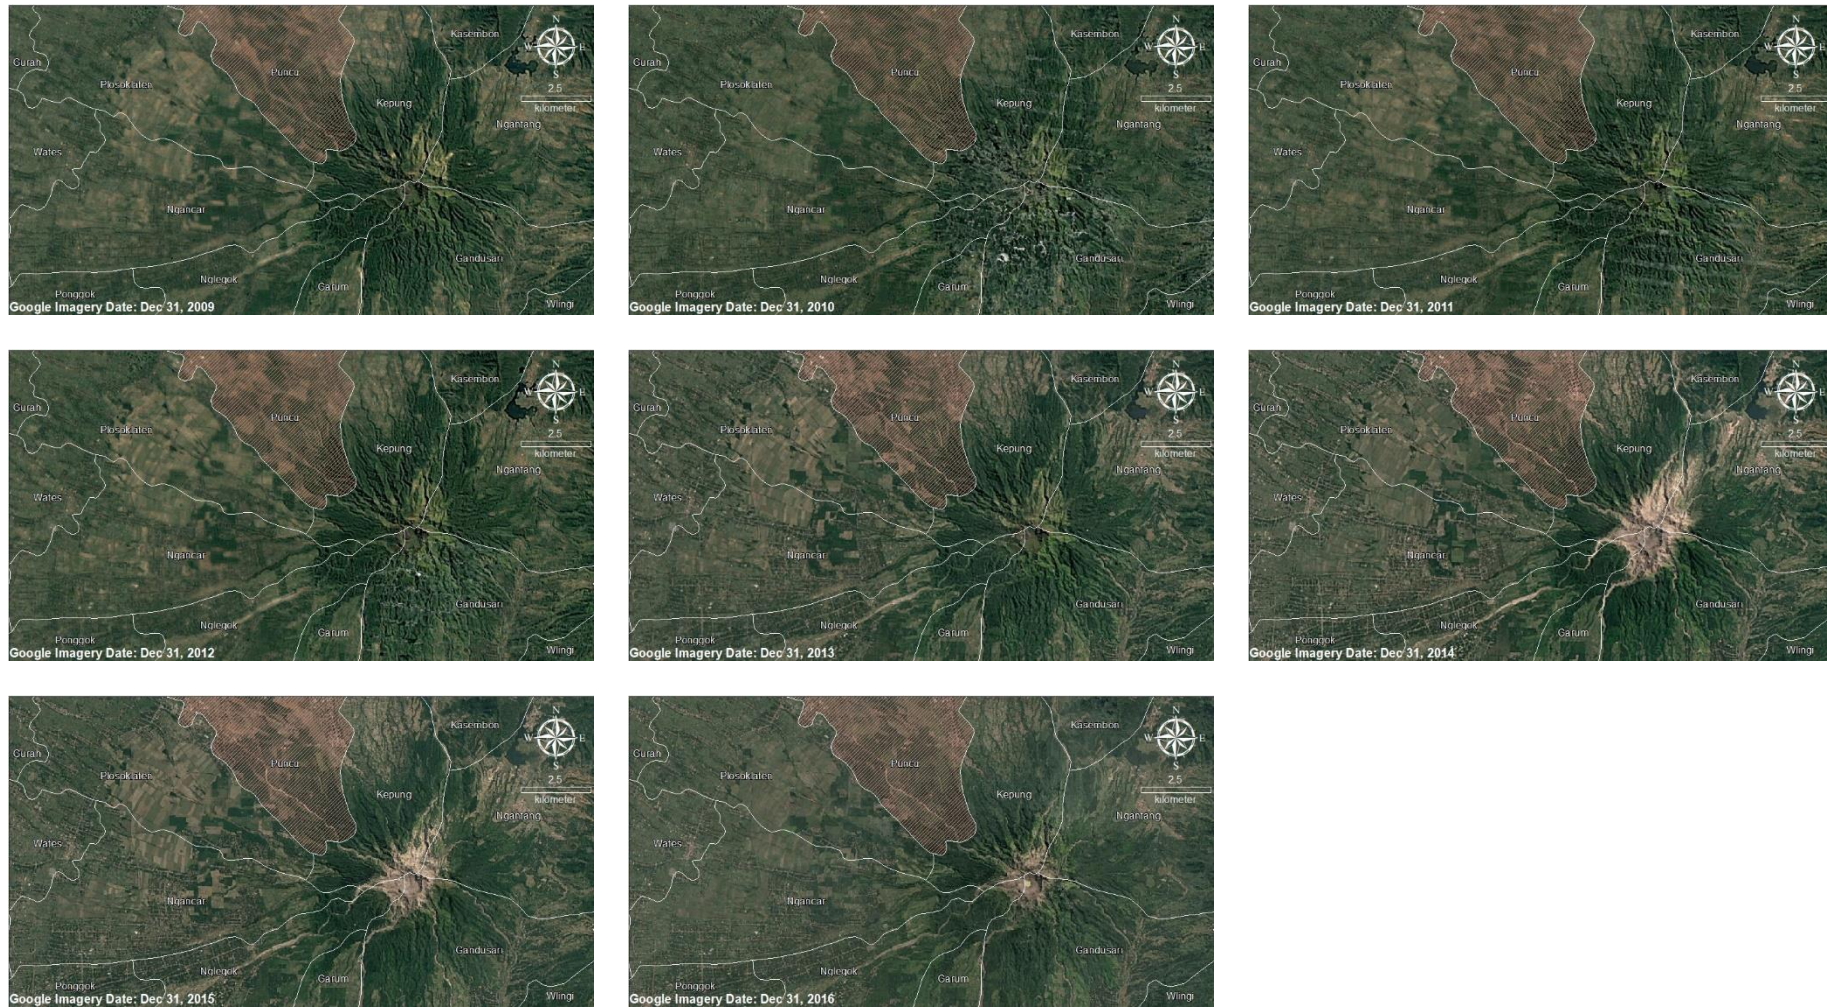
Figure 12 Satellite image (source: google earth) sequences from December 2010 to December 2016 of Mount Kelud. The condition of Mount Kelud was enclosed by vegetation till 2013, however in 2014 there was an opened area without any vegetation (stressed vegetation).

Based on Pusat Vulkanologi dan Mitigasi Bencana Geologi (PVMBG) information, last time the Mount Kelud erupted was on February 13th 2014 with a relatively brief time of eruption (Wasono, 2014). The eruption was generating 20 km – 30 km of elevation of volcanic ash so that created lots of new volcanic material. The process of last Mount Kelud eruption has made the vegetation around top Mount Kelud has burned or buried by the volcanic material, furthermore it became an arid or barren area, deforestation Mount Kelud (Figure 12). The benefits of forest in Kelud Mountain becoming groundwater regulators in the hydrogeological cycle are disrupted, because forests behave like giant sponges that can absorb rainwater during the rainy season and slowly release it during the dry season. In normal conditions, Mount Kelud Forests provide infiltration and water storage systems based on the presence of tree roots and leaf litter so as to create conditions that drive rainwater infiltration into the soil and then into ground water, store it during the rainy season and provide water supply during dry period.
